Ellis (Roxbury) Pond Watershed Survey Report

JANUARY 2015

ELLIS POND WATERSHED COMMITTEE

Report Prepared by Laura Crossley of the
Maine Conservation Corps, AmeriCorps

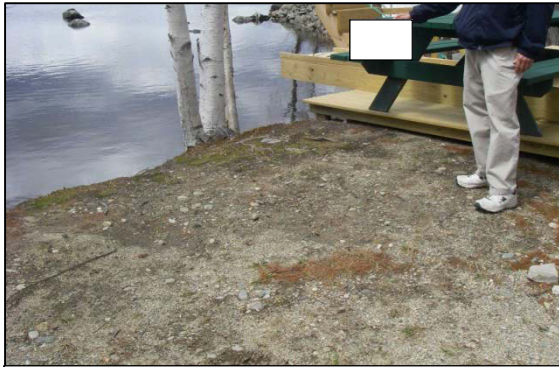
This **low** impact site was a small area of sheet erosion going directly into the lake. Surveyors noted that this would be an easy and low cost fix by adding some erosion control mix (ECM) to the bare area.

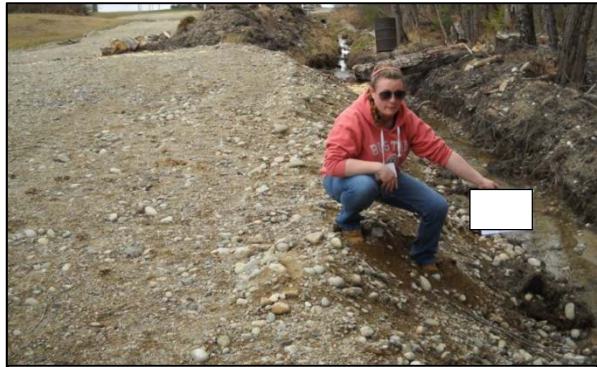
This **high** impact had piles of bare soil and an eroding ditch that leads to the pond. The ditch along the edge of the property needs to be armored with vegetation or stone and the soil piles in the back should be covered.

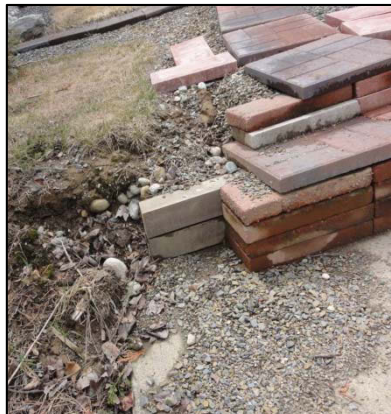
At this **low** impact site, roof runoff spills on and around this path, sweeping soil into the lake. The issues could be fixed by installing a drywell at the gutter downspout and planting along the shoreline.

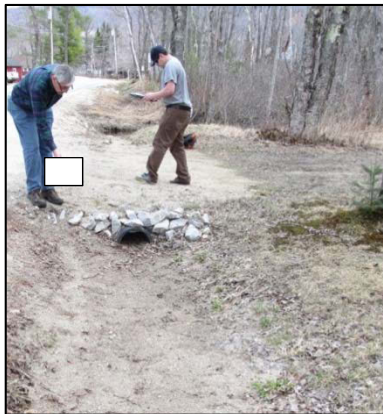
This **medium** impact driveway site had an unstable culvert under the driveway. There was a small area of rill erosion that connected directly with a ditch or stream. Eroded sediment has filled up the culvert.

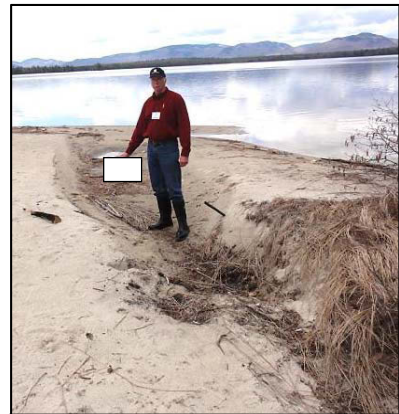
This **medium** impact site was the combination of two small areas of erosion. A culvert on the property had become clogged, which then backed up during high flows, eroding both above and below the culvert.

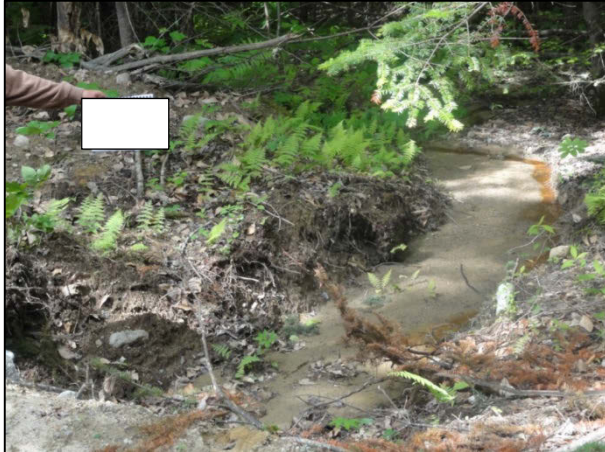
Surveyors documented this as a **high** impact trail site where severe surface erosion of trail travels about 0.1 miles and flows directly into a stream.

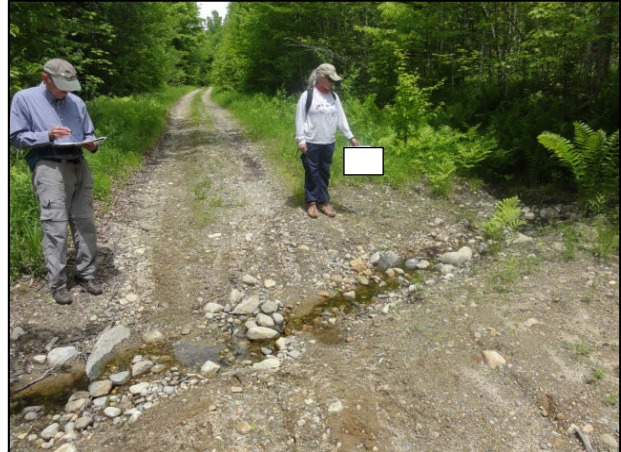
This **high** impact trail site experienced moderate trail surface and shoulder erosion over a large length of the trail, going directly into the stream.

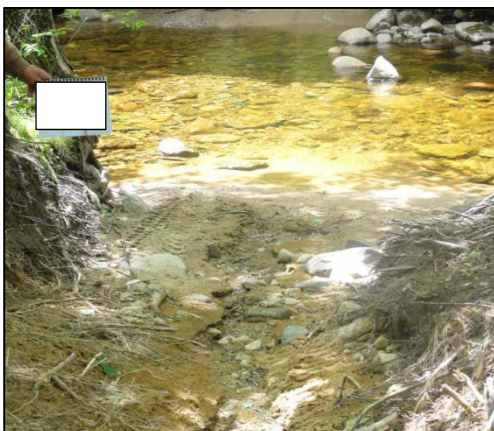
This was a **high** impact site where ATVs cross through a stream. One suggestion was to block access and/or put signs up educating trail users about protecting water quality and directing them to use the nearby bridge crossing.

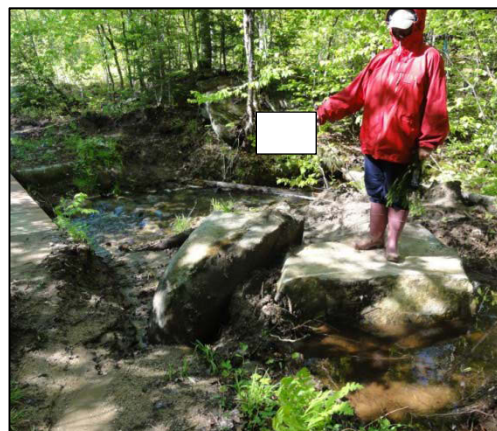
An unstable culvert and bridge on this **medium** impact trail were severely eroding into the stream. Surveyors suggested enlarging the culvert and armoring the inlet and outlet with stone for stability.

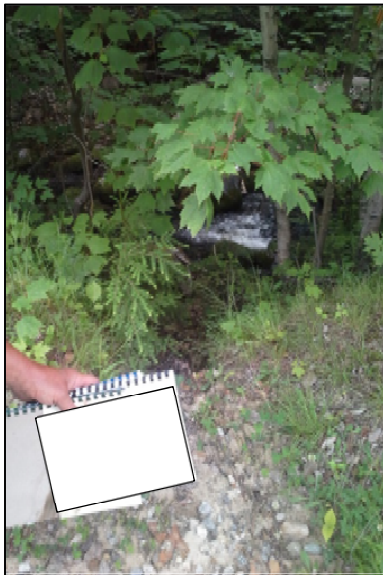
This **high** impact town road site deposits sediment directly into a stream. A grader berm at the edge of the road trapped runoff on the road, which then eroded the road.

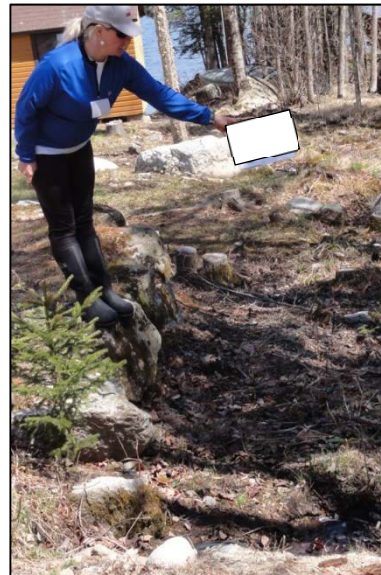
This **low** impact private road site had an unstable culvert inlet/outlet and road material that had washed into the ditch. The eroded area, however, was small and appeared to have significant buffering before reaching the lake.

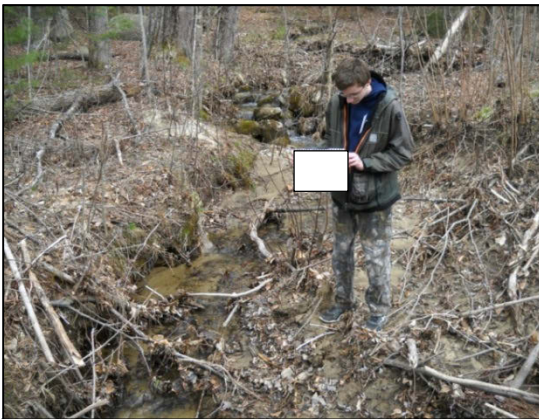
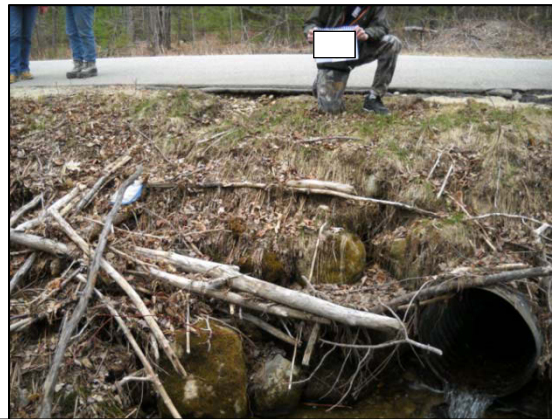
Before - This Roxbury town road site originally ranked as **high** impact with moderate road surface erosion, several road shoulder erosion and winter sand deposition into the stream.

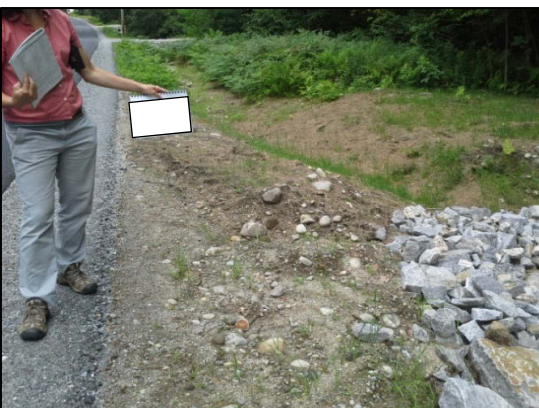
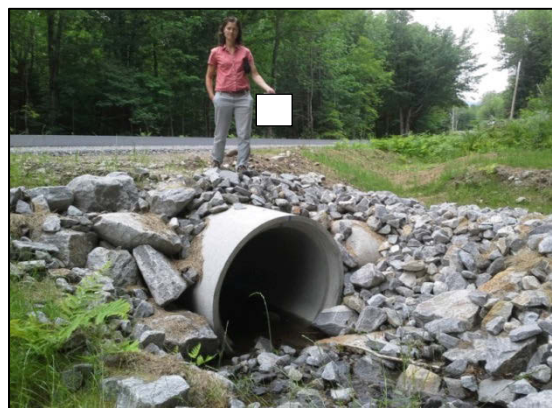
After— Town road site after the road work was completed. As shown in the picture to the left, the road shoulder is still slightly unstable, rendering the site a **low** impact, rather than a no impact site. The new culvert is larger and its ends have been stabilized with stone.

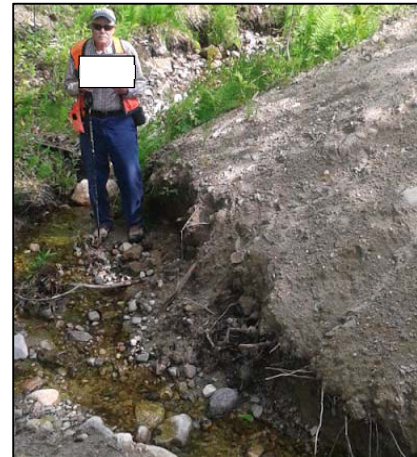
This **high** impact site is one of several sites where culverts had been removed, but the banking had not been stabilized. The exposed areas next to the stream need to be lessened and stabilized with vegetation or stone.

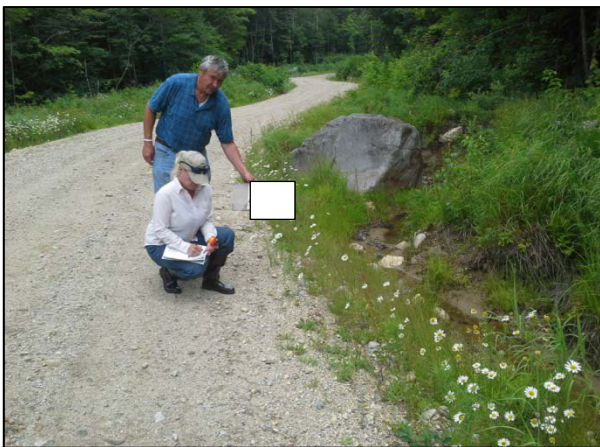
At the other end of the impact scale, this **low** impact site involved an unstable culvert crossing under the road and the beginning signs of bank failure in the ditch.

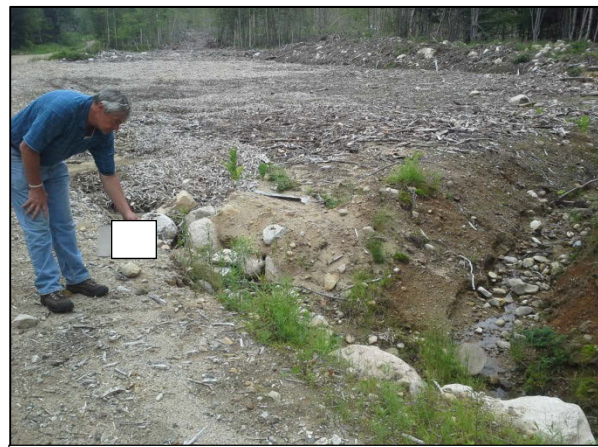
This **high** impact logging site was a large area that flowed under the access road via a culvert and then directly into a stream. This site was atypical of logging sites, in that there were not that many landings documented.

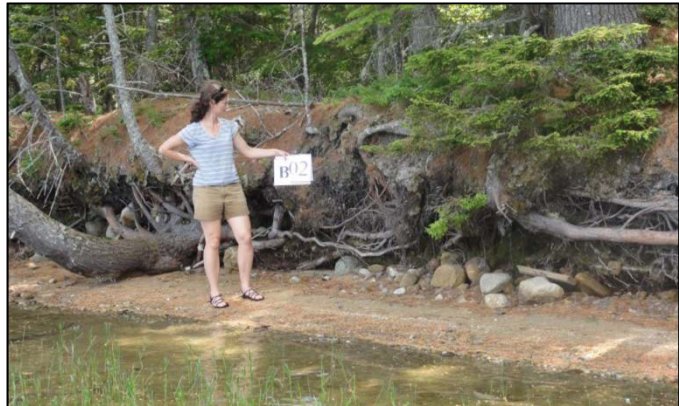
Several sections of the lake's undeveloped shoreline were severely eroding with undercut banks and destabilized trees. It was difficult to discern how much of this erosion was natural or related to human activity. However, lowering the dam would likely reduce the current water level and decrease the amount of time during the year that the banks are reached by wave action.

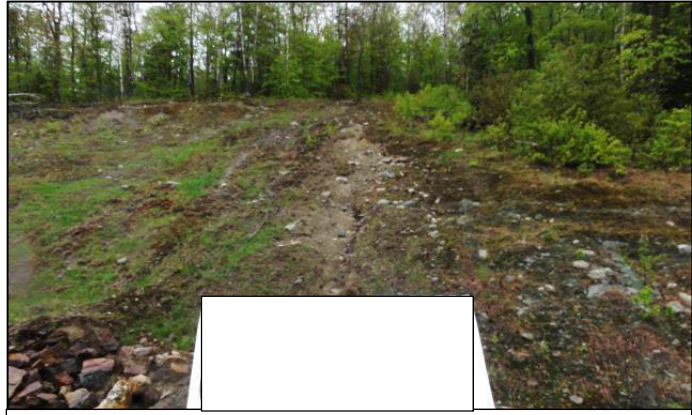
Issues at the wind towers were located on the short steep slopes next to the road. This **low** impact site had a steep embankment above the road that has had difficulty establishing vegetation.
