Ellis (Roxbury) Pond Watershed Survey Report

JANUARY 2015

ELLIS POND WATERSHED COMMITTEE

Report Prepared by Laura Crossley of the
Maine Conservation Corps, AmeriCorps

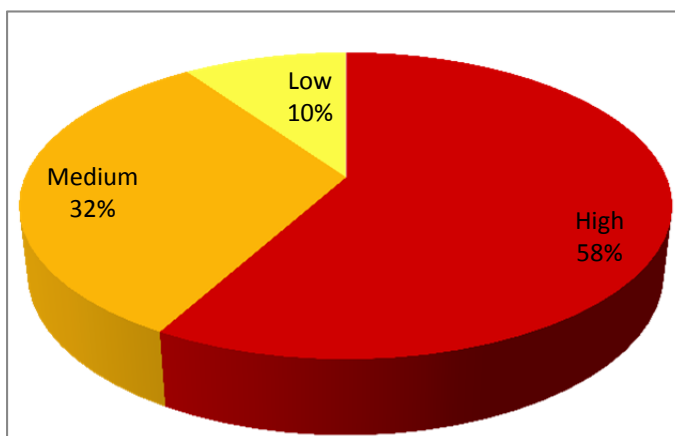
Figure 10: Logging impacts

This **high** impact site is one of several sites where culverts had been removed, but the banking had not been stabilized. The exposed areas next to the stream need to be lessened and stabilized with vegetation or stone.

- ❖ Repair, replace, armor, and otherwise improve upon culverts.
- ❖ Properly size culverts and other stream crossing structures.
- ❖ Install sediment pools to capture eroded material.
- ❖ Vegetate ditches.
- ❖ Armor ditches with stone and install check dams.
- ❖ Install runoff diverters, waterbars, and turnouts.
- ❖ Adjust slope of road and/or add hard-packing surface material.
- ❖ Raise awareness of other erosion prevention techniques, such as the road “rock sandwich”.
- ❖ Properly close out trails and roads.
- ❖ Seek advice from Maine DEP and Maine Forest Service to handle difficult or questionable areas where habitat resources may be of concern.
- ❖ Utilize Maine Forest Service’s Best Management Practices for Forestry Handbook.
